**PRE-SUBSIDENCE SURVEY
PRIOR TO FULL EXTRACTION AT THE
14th AND 15th WEST PANELS**

CONSOLIDATION COAL COMPANY

Emery Mine
Emery County, Utah

April 2007

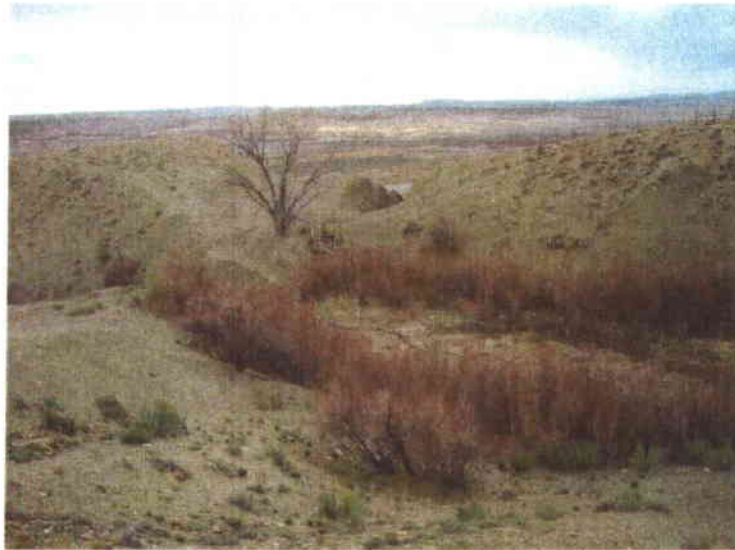
Feature 30. Breached Reservoir Embankment. This feature has been updated from the Valley Engineering (1980) report. It is the site of a former embankment that created a pond in a large gully. The left and right sides of the embankment remain intact, but the center portion has apparently been eroded away. The embankment remnant is approximately 20 feet tall on the downstream side, and used to span approximately 140 feet across the gully. The remains of a dilapidated drainage diversion structure are located near the top of the embankment on its south side. This structure probably served to convey water to the south through an incised notch for irrigation. The gully bottom was marshy and grassy when it was surveyed (April 2007), and this is due to the fact that irrigation ditches discharge into its headwaters.

Feature 30. Breached Reservoir Embankment. Looking south. Note diversion structure and deeply incised ditch on south side of gully.

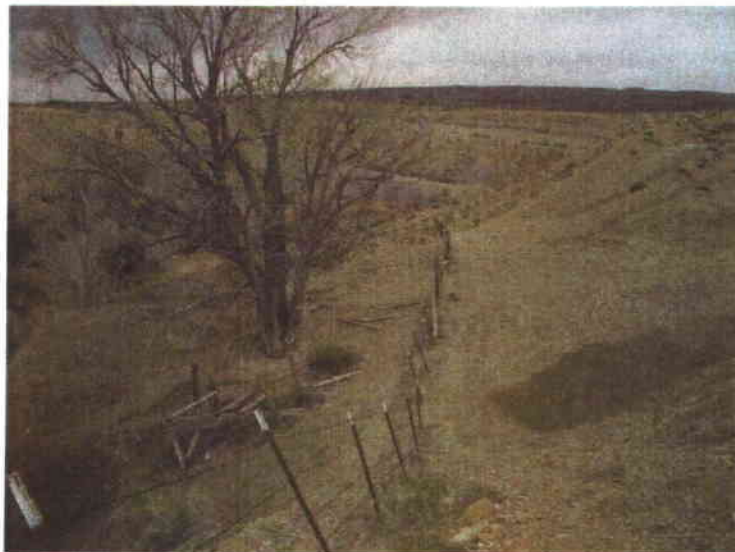
Feature 30. Breached Reservoir Embankment. Looking east at the south side of the embankment.

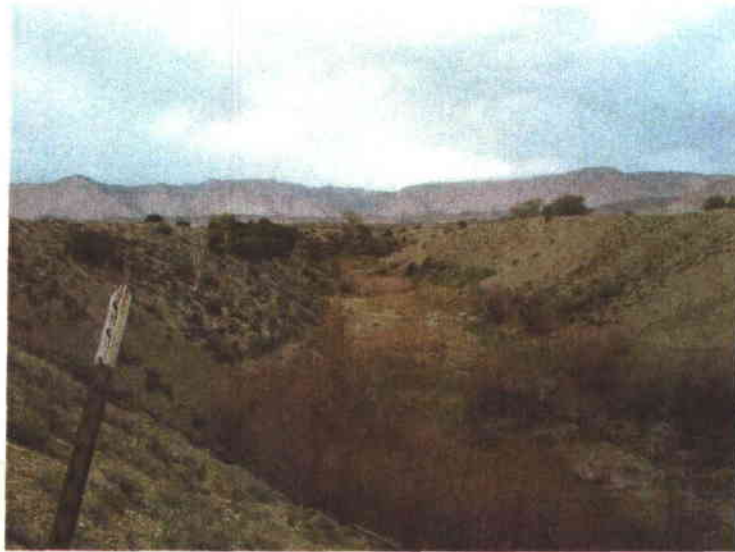
Feature 30. Breached Reservoir Embankment. Looking west up the gully from near the breached embankment. The bottom of the gully is marshy and grassy due to irrigation ditches discharging into the gully at its upstream end.

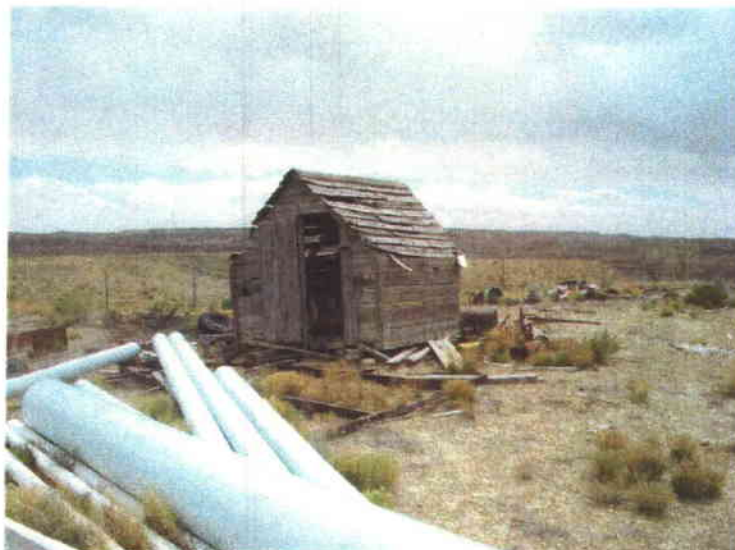
Feature 31. Small Shed, Building Foundation, and Corrals. The description of this feature has been updated from the Valley Engineering (1980) report. It contains a cluster of features in poor condition. The shed is constructed of rough lumber and does not have a permanent foundation. It is placed upon rough cut tree limbs and may have been dragged to its current location. There are several gaps in the walls and roofing. A concrete building foundation, located approximately 20 feet southwest of the shed, is cracked on its east side. The corrals are located approximately 600 feet northwest of the shed, and are constructed from wooden fencing with some steel reinforcement. Many of the fence posts and lattices have fallen out of plumb.

Feature 31. Small Shed, Building Foundation, and Corrals. Looking southeast at shed.

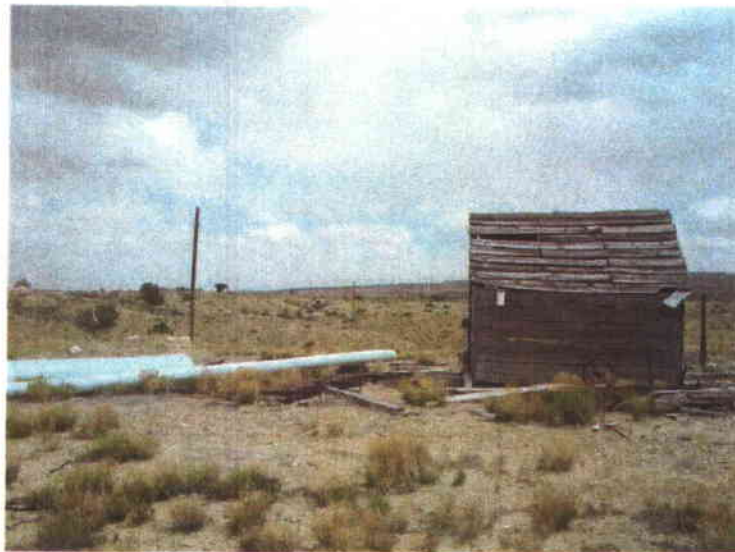
Feature 31. Small Shed, Building Foundation, and Corrals. Looking east at shed.

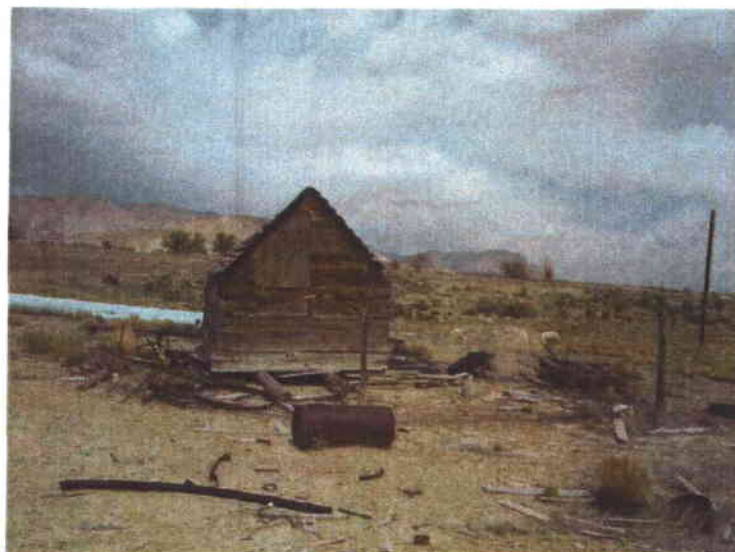
Feature 31. Small Shed, Building Foundation, and Corrals. Looking north at shed.

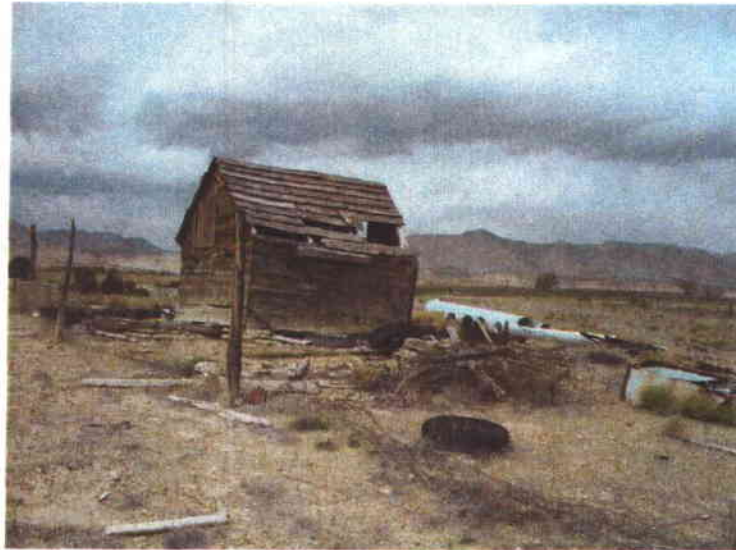
Feature 31. Small Shed, Building Foundation, and Corrals. Looking west at shed.

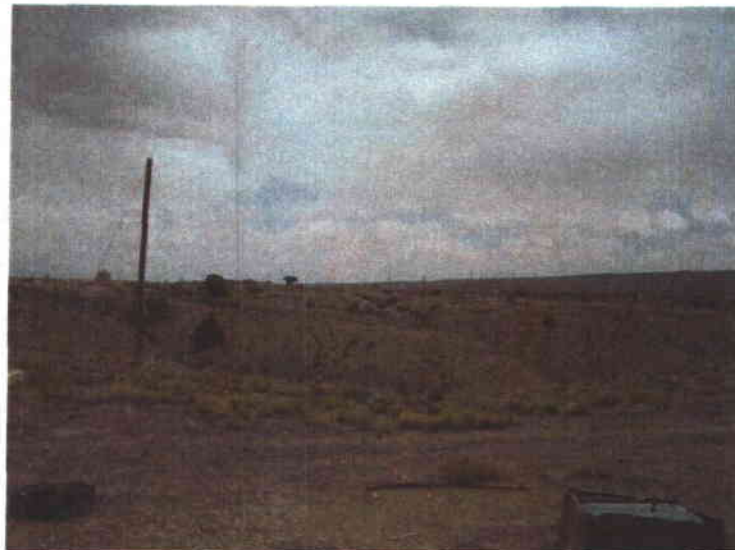
Feature 31. Small Shed, Building Foundation, and Corrals. Looking east at power lines that lead from the paved road to the shed.

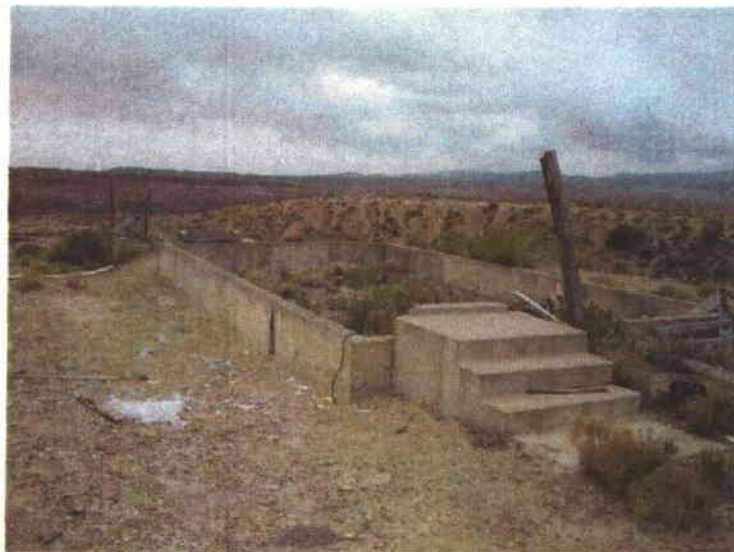
Feature 31. Small Shed, Building Foundation, and Corrals. Looking south at foundation.

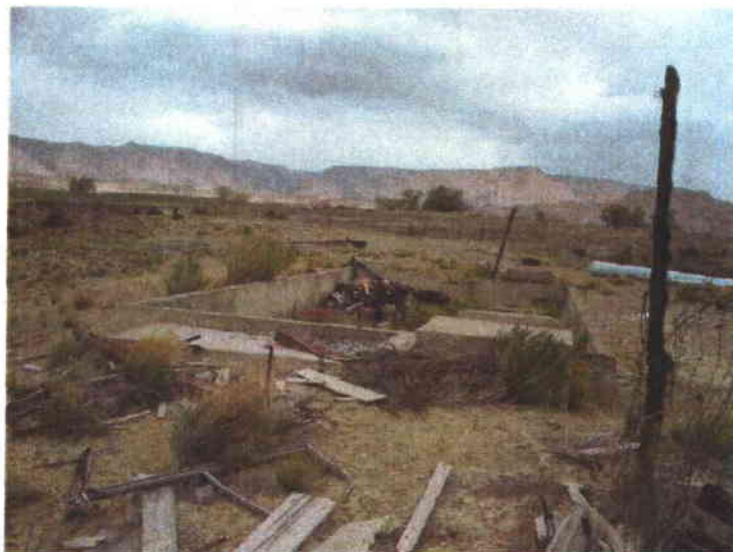
Feature 31. Small Shed, Building Foundation, and Corrals. Looking north at foundation.

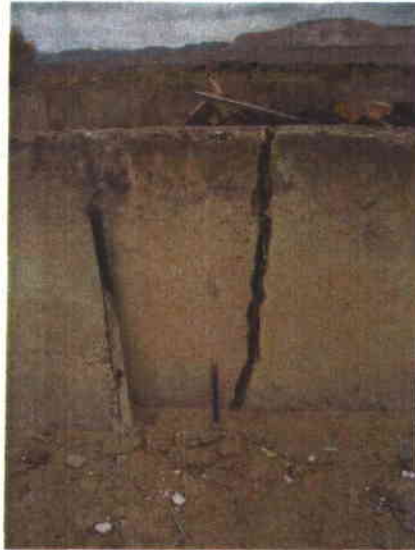
Feature 31. Small Shed, Building Foundation, and Corrals. Looking at crack near northeast corner of foundation.

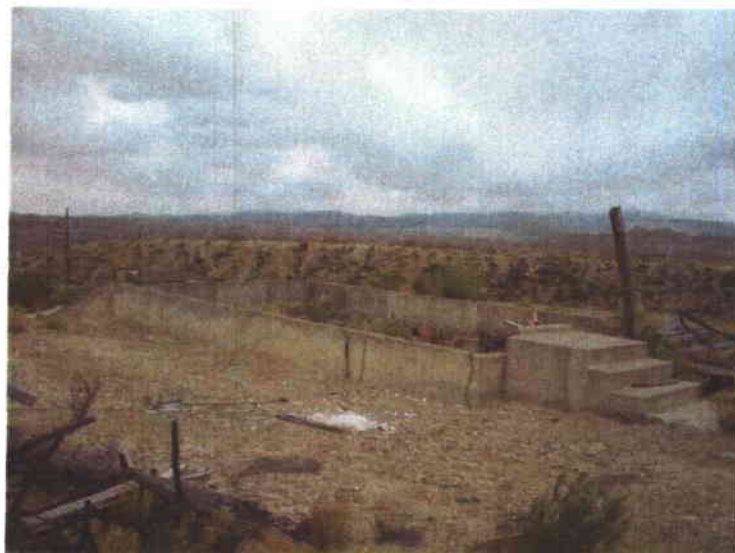
Feature 31. Small Shed, Building Foundation, and Corrals. Looking southwest at foundation.
Note crack.

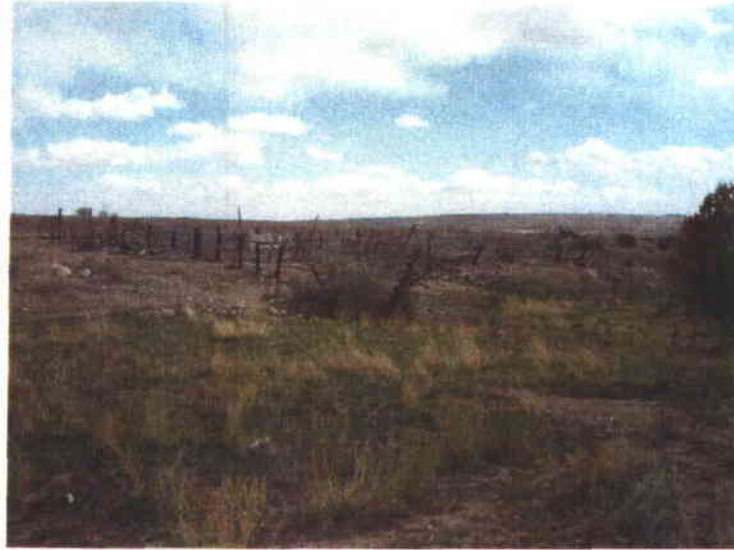
Feature 31. Small Shed, Building Foundation, and Corrals. Looking east at corral.

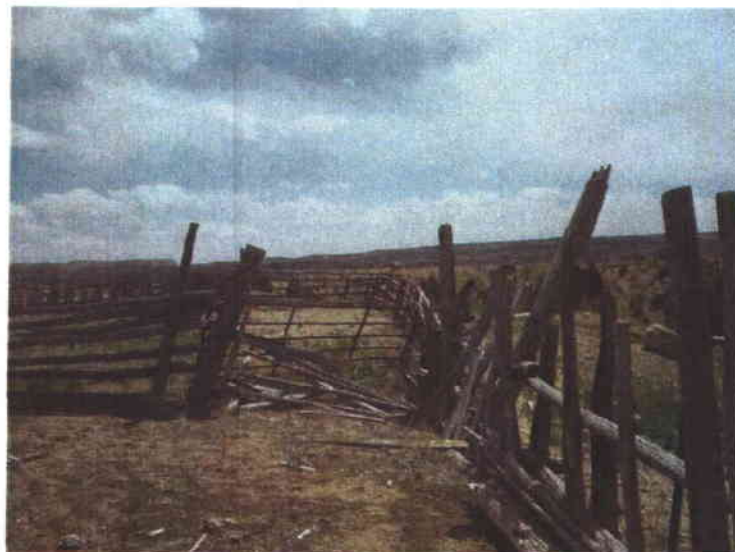
Feature 31. Small Shed, Building Foundation, and Corrals. Looking southeast at corral.

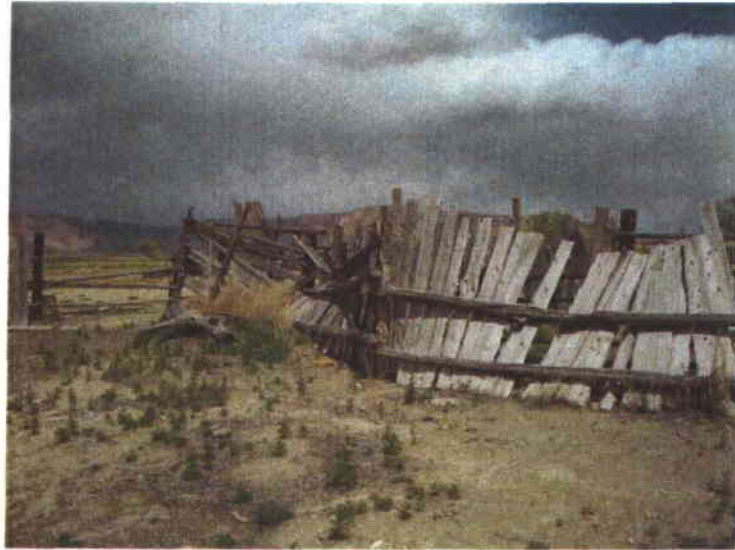
Feature 31. Small Shed, Building Foundation, and Corrals. Looking northwest at corral.

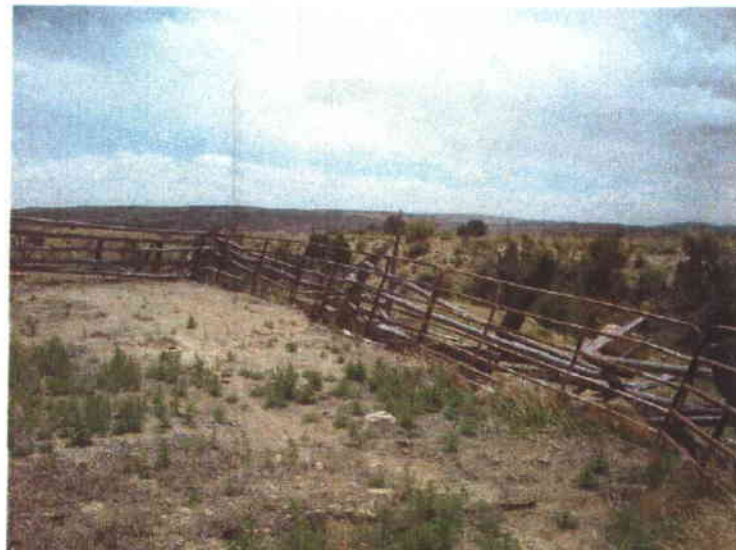
Feature 31. Small Shed, Building Foundation, and Corrals. Looking south at corral.

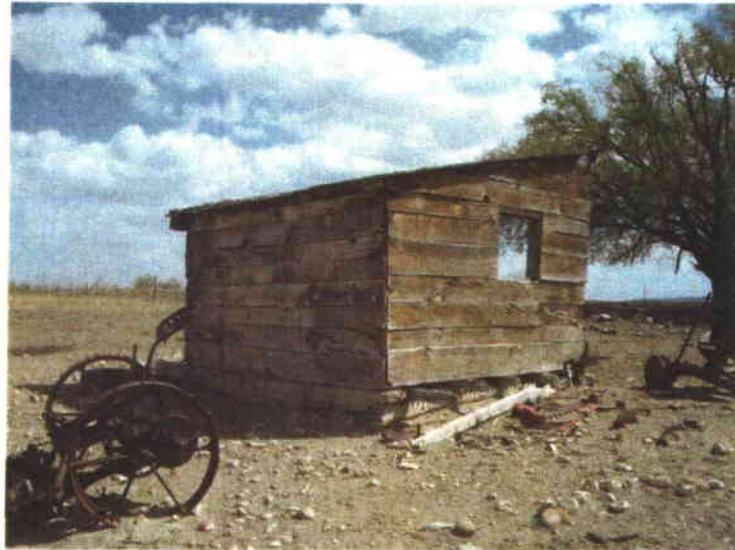
Feature 65. Corral and Small Shed. The description of this feature has been updated from the Valley Engineering (1980) report. The corral is constructed of rough cut lumber poles with steel fencing reinforcement. The shed is constructed from rough cut boards, and has masonry reinforcement on the inside walls. The shed is founded on wooden poles. Both the shed and the corral are in fair to poor condition.

Feature 65. Corral and Small Shed. Looking northeast at the shed.

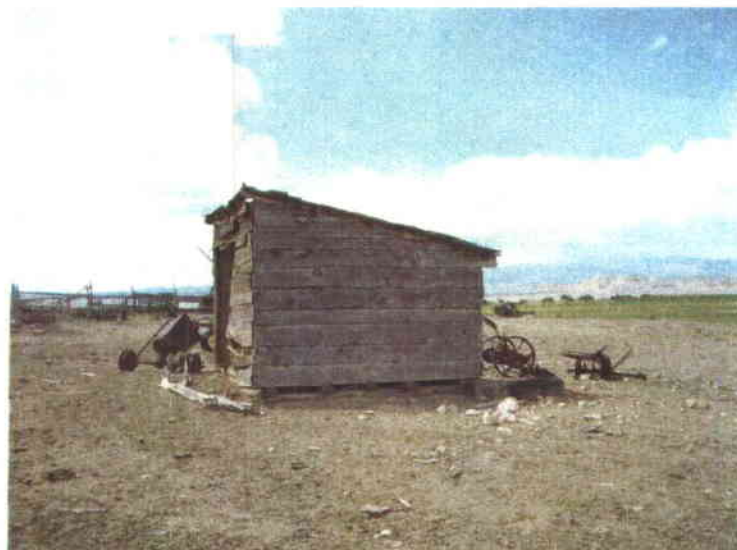
Feature 65. Corral and Small Shed. Looking south at the shed.

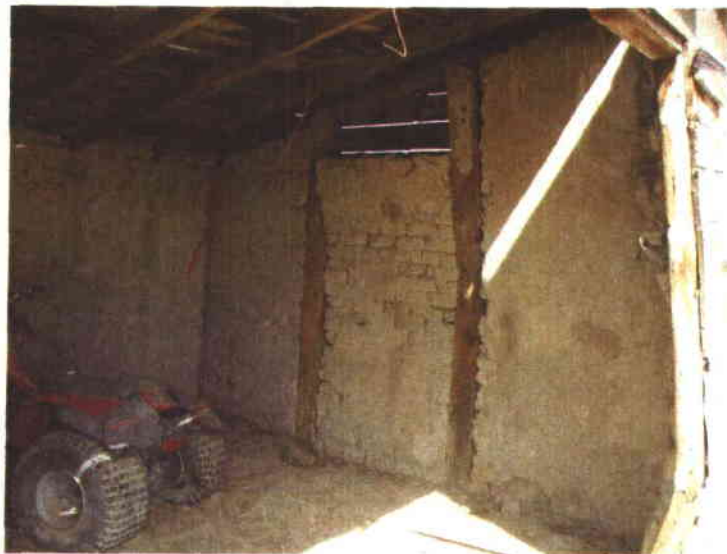
Feature 65. Corral and Small Shed. Looking west into the shed.

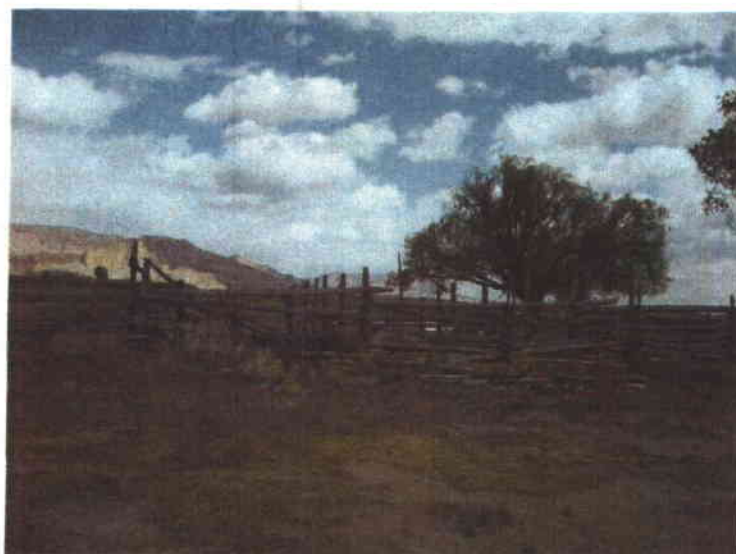
Feature 65. Corral and Small Shed. Looking at the north wall of the corral.

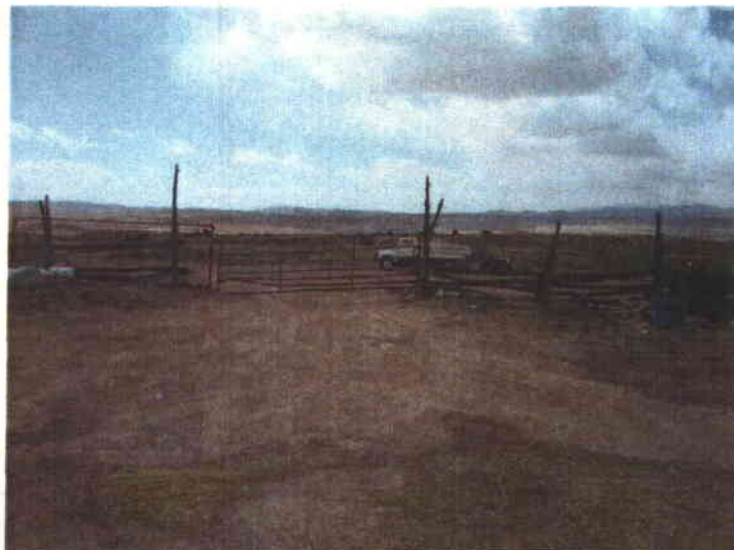
Feature 65. Corral and Small Shed. Looking at the south wall of the corral.

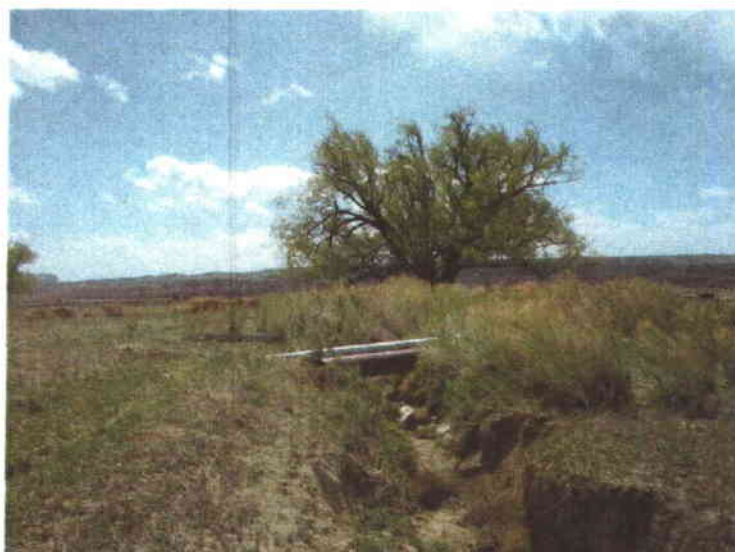
Southeast of Feature 65. Photo looking southeast at irrigation ditch and culvert. Approximate location of photo is UTM E 476,621 m, N 4,303,607 m (WGS 84 Datum).

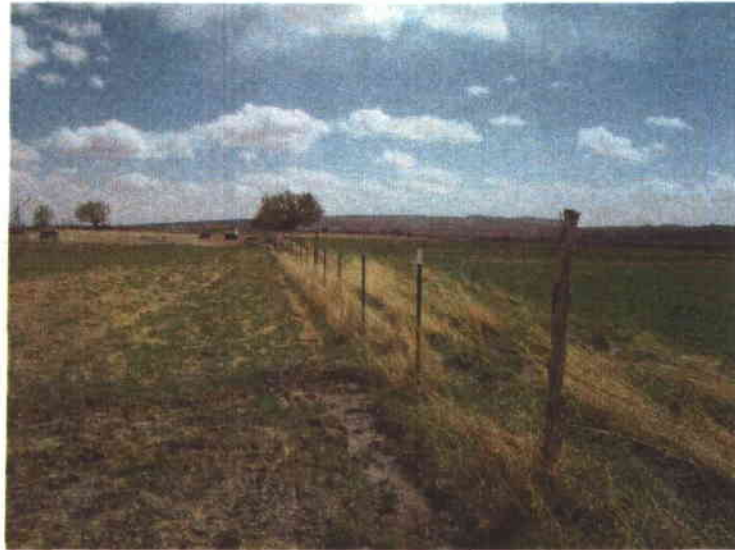
West of Feature 65 looking east along irrigation ditch. Feature 65 is visible near the horizon on the left of the photograph.

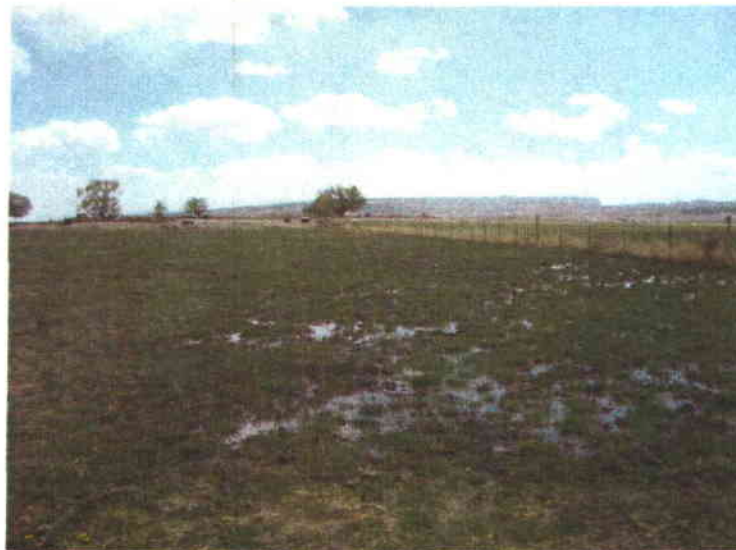
West of Feature 65 looking east along irrigation ditch. Feature 65 is visible near the horizon on the left of the photograph. This photograph was taken from just northwest of the previous photograph. Note ponding left (north) of the ditch.

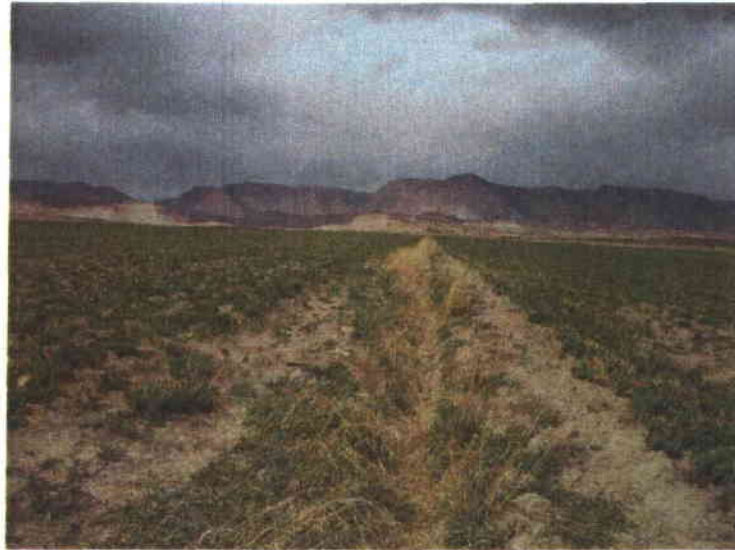
Photograph looking west-northwest at irrigation ditch. This ditch is located west of Feature 31 and eventually feeds the drainage in which Feature 30 is located. The approximate location of where this photograph was taken is UTM E 476,353 m, N 4,303,446 m (WGS 84 Datum).

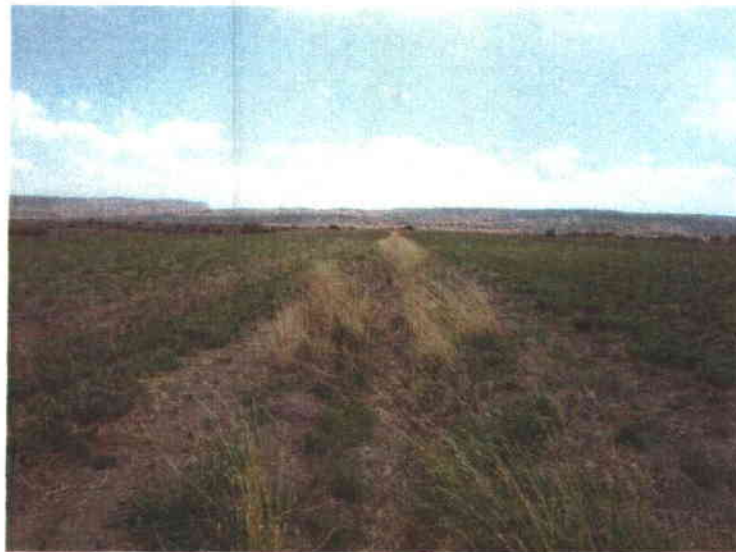
Photograph looking east-southeast at the same irrigation ditch as in the previous photograph. The photograph was taken from the same location as the previous photograph.

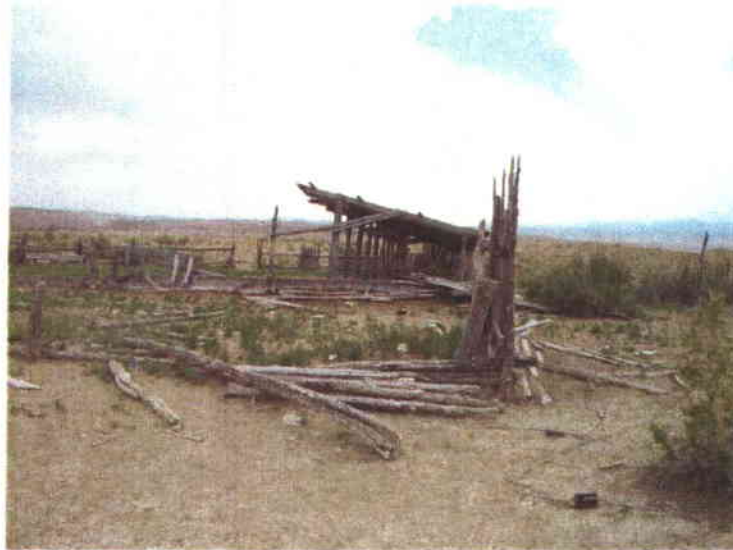
Feature 107. Corrals and Covered Shelters. The description of this feature has been updated from the Valley Engineering (1980) report. The corrals and shelters are in poor

condition and are constructed of rough cut lumber and rough sawn boards. Several pieces of the fence are missing. The land slopes steeply downward just to the south of the corrals toward a broad, flat plain. During site reconnaissance in April 2007, a marshy, grassy area was observed near the base of this slope. This marshy area corresponds to SP-9 on Plate VI-2/VI-2A and in the text of Chapter VI Volume 1 Section VI.A.2 (Springs and Seeps) of the Emery Mine Permit (Consolidation Coal Company, 1990). As indicated in that permit document, SP-9 is the result of irrigation water and not a spring.

Feature 107. Corrals and Covered Shelters. Looking south at west portion of corral and covered shelter.

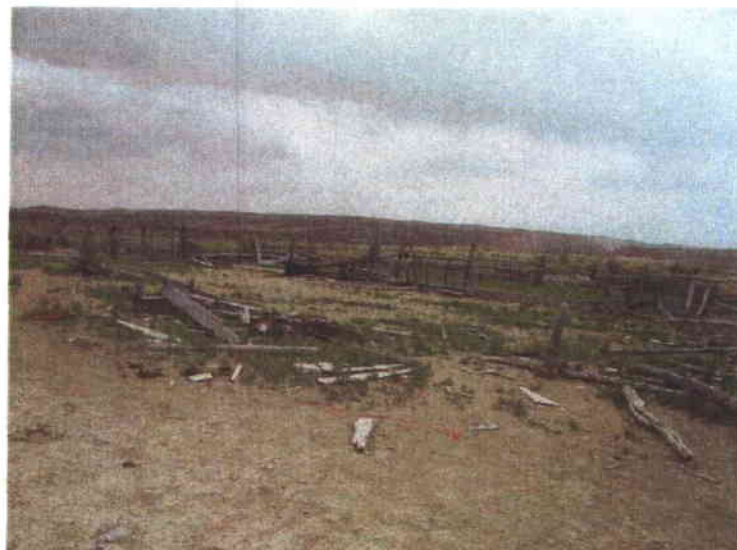
Feature 107. Corrals and Covered Shelters. Looking southeast at east portion of corral and covered shelter.

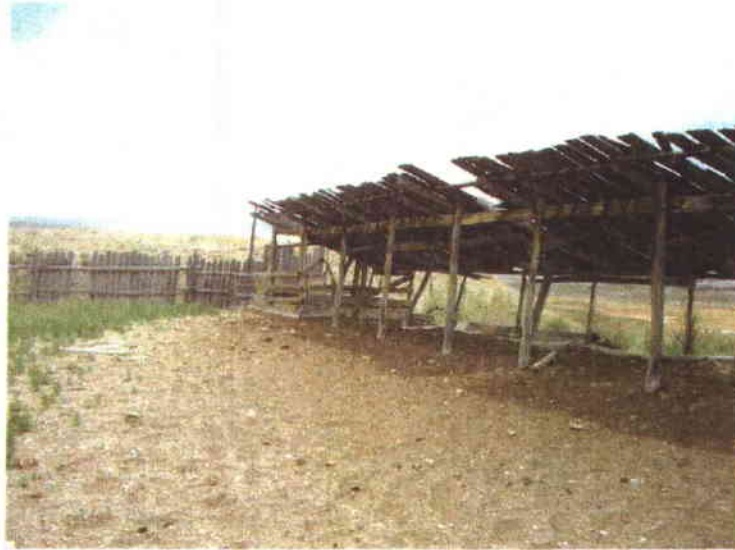
Feature 107. Corrals and Covered Shelters. Looking southwest at covered shelter.

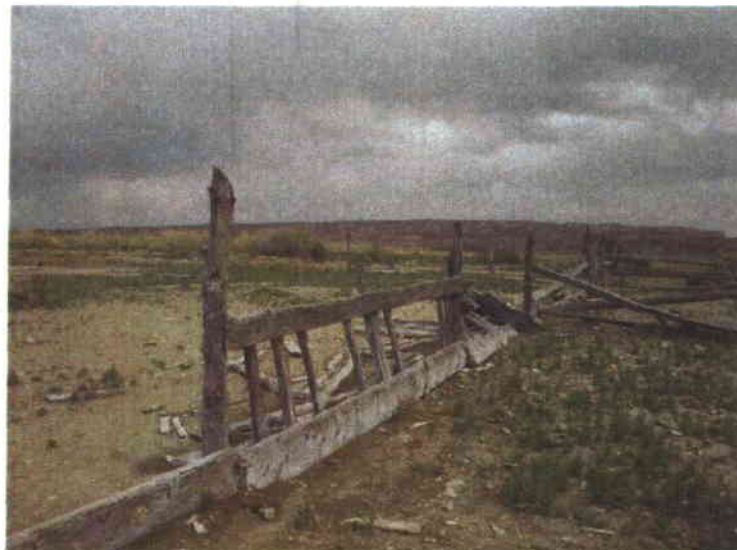
Feature 107. Corrals and Covered Shelters. Looking east along northern edge of corral.

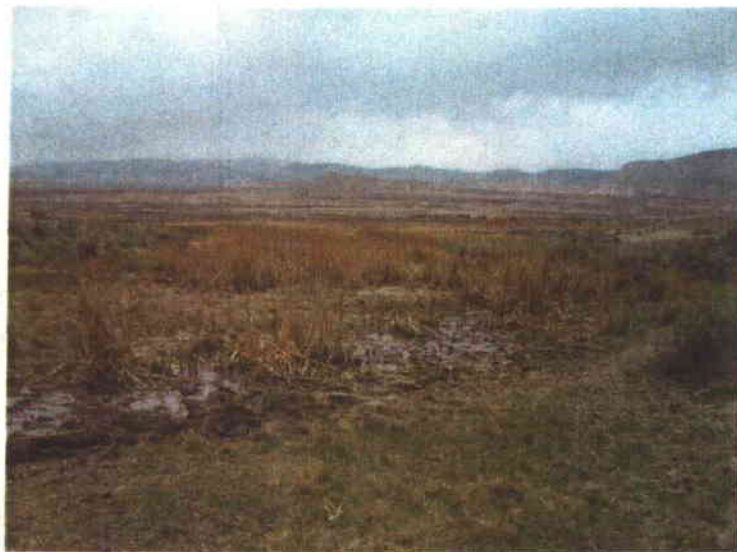
Feature 107. Corrals and Covered Shelters. Looking southwest at marshy, grassy area below and south of the corral and covered shelters. (Photo taken April 2007)

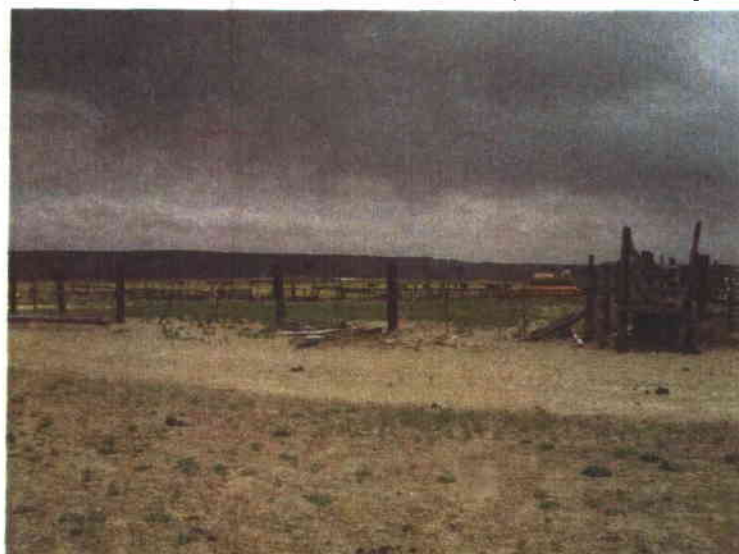
Feature 108. Corral. The description of this feature has been updated from the Valley Engineering (1980) report. This feature is in fair condition. It is constructed from square rough-cut wood posts, unfinished wood posts, and steel fencing reinforcement. Most of the corral is fenced with barbed wire. During site reconnaissance in April 2007, several hay bales were being stored in the corral, suggesting that it was being used.

Feature 108. Corral. Looking South.

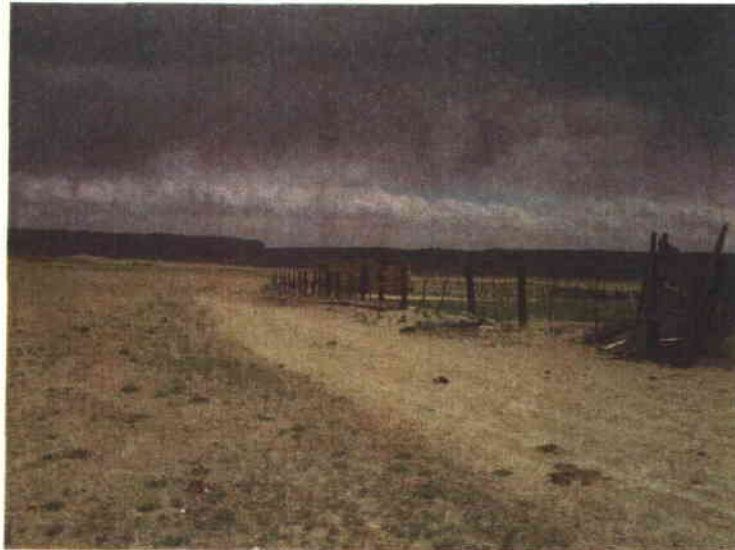
Feature 108. Corral. Looking east.

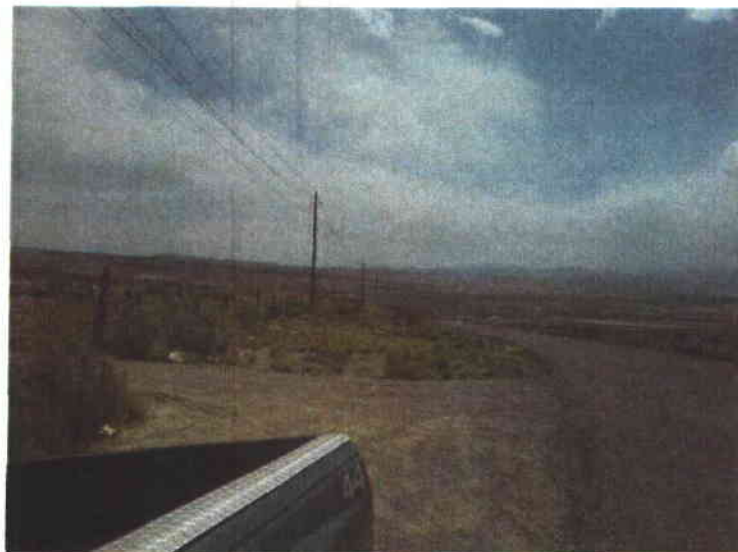
Photograph looking south from the intersection of the paved road with the two unimproved roads just north of the area boundary.

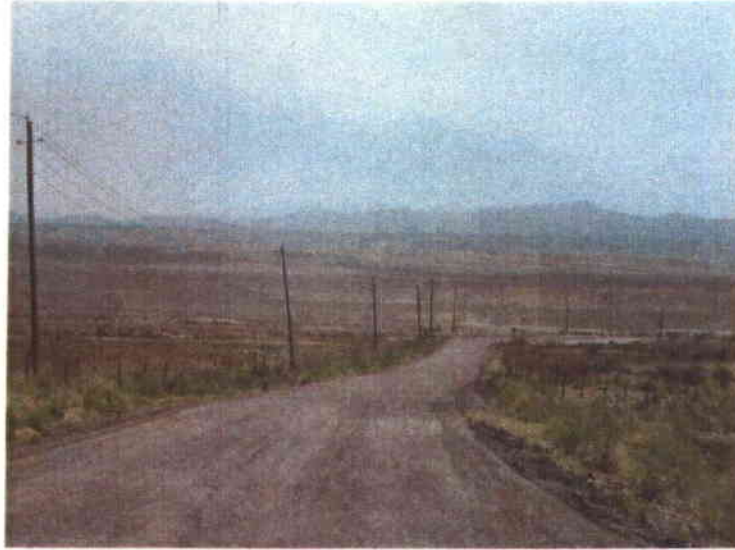
Photograph looking south along the paved road that crosses the site area. The Consol Mine road can be seen in the distance. Note that some of the power poles lean slightly leftward.
